**Flood Control Project Maintenance
Levee Inspections**

Fall 2018 Levee Maintenance Deficiency Summary Report

Reclamation District No. 0787 Fair

Waterway			Bank	Unit Miles
Unit No. 01 Colusa Basin Drain			Left	4.45
	Spring (March - May)	Summer (June - August)	(September - November) Fall	Winter (December - February)
Unit Maintenance Rating (Fall Only)			A	
Date of Inspection	3/16/2018 - 3/16/2018		10/9/2018 - 10/9/2018	
DWR Inspector	Zach Jojola		Zach Jojola	
Accompanied By	Roger Cornwell Rivergarden Farms RD 787

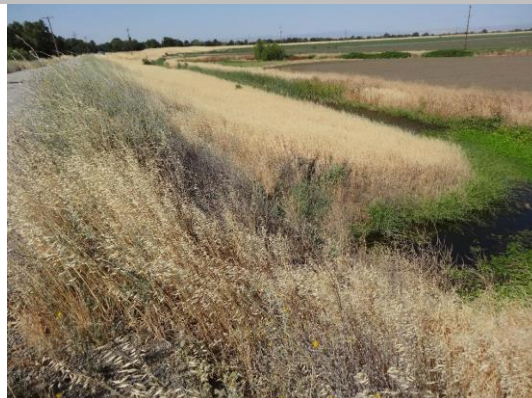
Photo 1 of 3 : UCIP_FA_2018_37585_68154.jpg

Comment Code					
Inspector Comment					
FS_ID:37585 DS_ID:22892 EP_NO: 9392 Repair Type: Non-Urgent Crossing Status: Found UCIP Comments: Dense vegetation limits the inspector's visibility to identify signs of pipe failure (leaks) along the slope. Recommend removing vegetation along pipe alignment to conduct proper inspection of structure. FIELD_STRUCT_DESC: 36-inch concrete irrigation pipe through the levee, 17 feet below the crown. Slide gate in 36-inch standpipe on the waterside (WS). 24-inch pipe from standpipe to pump house mounted on steel structure in channel. (36-inch pipe authorized under Automatic Board Order (ABO) issued as Permit No. 9392, 1974 - River Garden Farms; pump structure and 24-inch steel pipe authorized under Permit No. 3878, 1962-River Farms Company of California). [Additional Reference(s): DWR Levee Logs, 1990] FS Date: 6/10/2014

View of landward slope.

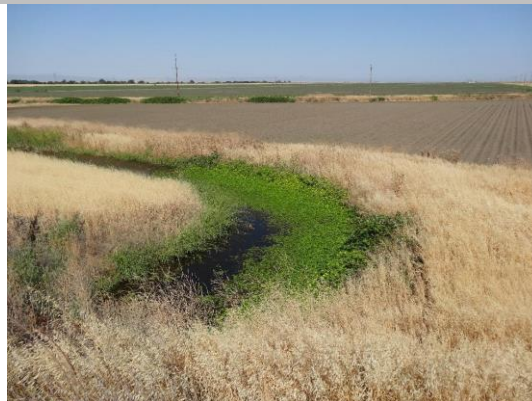
Photo 2 of 3 : UCIP_FA_2018_37585_68153.jpg

View of landward side.

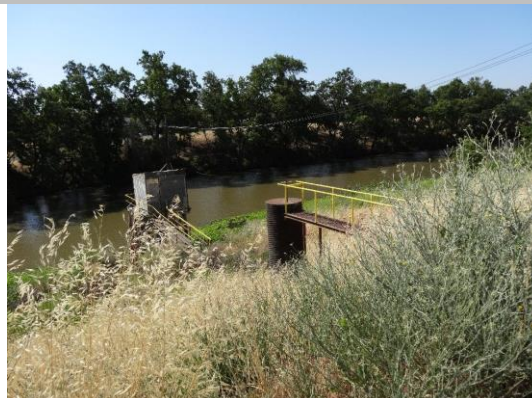
Photo 3 of 3 : UCIP_FA_2018_37585_68156.jpg

Comment Code						
Inspector Comment						
FS_ID:37585 DS_ID:22892 EP_NO: 9392 Repair Type: Non-Urgent Crossing Status: Found UCIP Comments: Dense vegetation limits the inspector's visibility to identify signs of pipe failure (leaks) along the slope. Recommend removing vegetation along pipe alignment to conduct proper inspection of structure. FIELD_STRUCT_DESC: 36-inch concrete irrigation pipe through the levee, 17 feet below the crown. Slide gate in 36-inch standpipe on the waterside (WS). 24-inch pipe from standpipe to pump house mounted on steel structure in channel. (36-inch pipe authorized under Automatic Board Order (ABO) issued as Permit No. 9392, 1974 - River Garden Farms; pump structure and 24-inch steel pipe authorized under Permit No. 3878, 1962-River Farms Company of California). [Additional Reference(s): DWR Levee Logs, 1990] FS Date: 6/10/2014

View of waterward side.

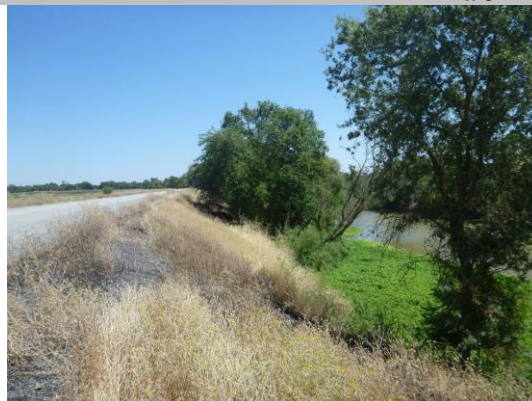
Photo 1 of 3 : LEVAL_FA_2018_182_1520.jpg

LM Start	0.73	Rating **	M	Issue No.	4
LM End	0.86	Issue Type +	Ma	Location *	
Category	Supplemental			GPS Latitude/Longitude	
				Start	End
Item	2017 Storm Damage			38.795769 °	38.796340 °
				-121.736798 °	-121.738956 °
DWR ID	DWR_RD0787_01_f_2017_4				
Comment Code					
Inspector Comment					
Levee Evaluation Comments					
Description:					
Site ID No:182					
Site Designation:RD 787-01					
Repair Type: Erosion					
Rating:Area of Concern					
Field Date:7/18/2017					
Notes:

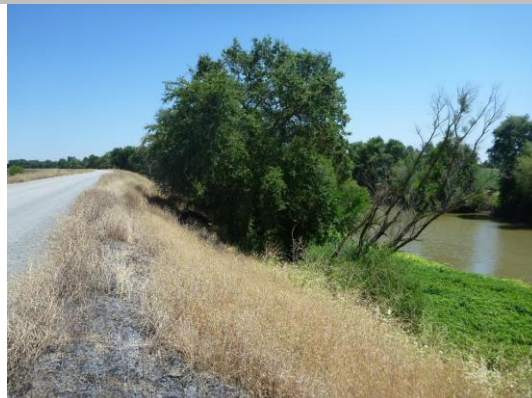
Photo 3 of 3 : LEVAL_FA_2018_182_1523.jpg

LM Start	0.73	Rating **	M	Issue No.	4 (cont)	
LM End	0.86	Issue Type +	Ma	Location *		
Category	Supplemental			GPS Latitude/Longitude		
				Start	End	
Item	2017 Storm Damage			38.795769 °	38.796340 °	
				-121.736798 °	-121.738956 °	
DWR ID	DWR_RD0787_01_f_2017_4					
Comment Code						
Inspector Comment						
Levee Evaluation Comments						
Description:						
Site ID No:182						
Site Designation:RD 787-01						
Repair Type: Erosion						
Rating:Area of Concern						
Field Date:7/18/2017						
Notes:

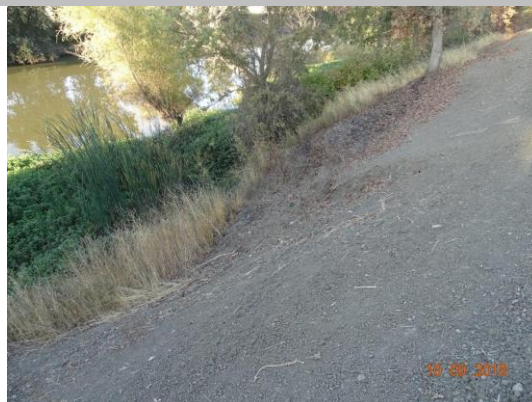
Photo 1 of 4 : FA_2018_RD0787_212_9_20181011_00013.jpg

LM Start	0.73	Rating **	A/W	Issue No.	9
LM End	0.73	Issue Type +	Ma	Location *	WS
Category	Earthen Levee			GPS Latitude/Longitude	
				Start	End
Item	Erosion / Bank Caving			38.795814 °	38.795814 °
				-121.736799 °	-121.736799 °
DWR ID	DWR_RD0787_01_s_2017_9				
Comment Code					
E1 : Note and monitor erosion site.					
Inspector Comment					
Erosion on the waterside slope from 2017 storms. Recommend monitoring.

View of erosion on the waterside slope, facing upstream. Fall 2018.

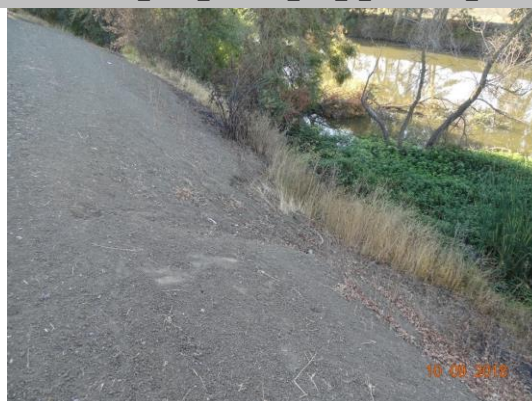
Photo 3 of 4 : FA_2018_RD0787_212_9_20181011_00014.jpg

LM Start	0.73	Rating **	A/W	Issue No.	9 (cont)	
LM End	0.73	Issue Type +	Ma	Location *	WS	
Category	Earthen Levee			GPS Latitude/Longitude		
				Start		End
Item	Erosion / Bank Caving			38.795814 °	38.795814 °	
				-121.736799 °	-121.736799 °	
DWR ID	DWR_RD0787_01_s_2017_9					
Comment Code						
E1 : Note and monitor erosion site.						
Inspector Comment						
Erosion on the waterside slope from 2017 storms. Recommend monitoring.

View of erosion, facing downstream. Fall 2018.

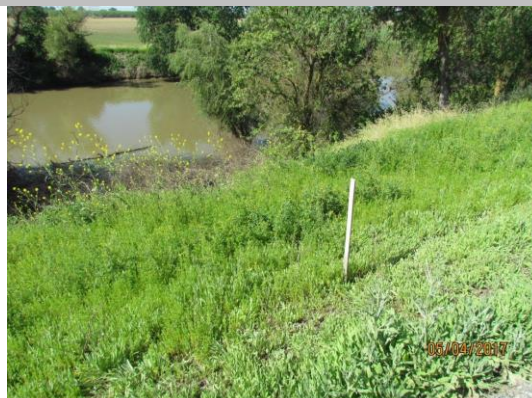
Photo 4 of 4 : FA_2018_RD0787_212_9_20180904_00004.jpg

View of what appears to be a slope stability issue on waterside slope.
Spring 2017.

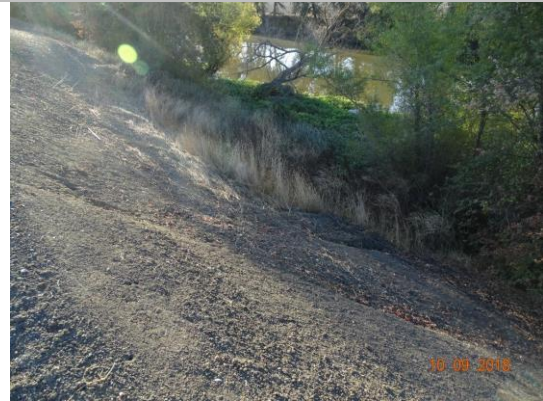
Photo 1 of 3 : FA_2018_RD0787_212_12_20181011_00015.jpg

LM Start	0.75	Rating **	A/W	Issue No.	12
LM End	0.75	Issue Type +	Ma	Location *	WS
Category	Earthen Levee			GPS Latitude/Longitude	
				Start	End
Item	Erosion / Bank Caving			38.795891°	38.795891°
				-121.737098°	-121.737098°
DWR ID	DWR_RD0787_01_f_2017_12				
Comment Code					
E1 : Note and monitor erosion site.					
Inspector Comment					
Erosion on the waterside slope from 2017 storms. Recommend monitoring.

View of erosion on the waterside slope, facing downstream. Fall 2018.

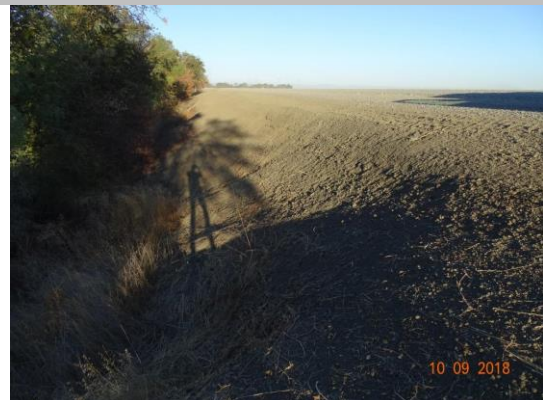
Photo 2 of 3 : FA_2018_RD0787_212_12_20181011_00016.jpg

View of the erosion the waterside slope, facing upstream. Fall 2018.

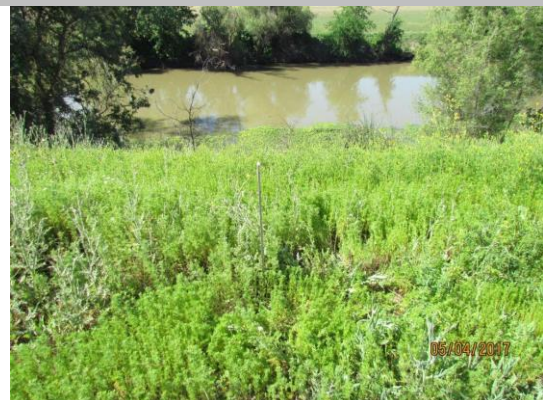
Photo 3 of 3 : FA_2018_RD0787_212_12_20180904_00005.jpg

View of what appears to be a slope stability issue on waterside slope.
Spring 2017.

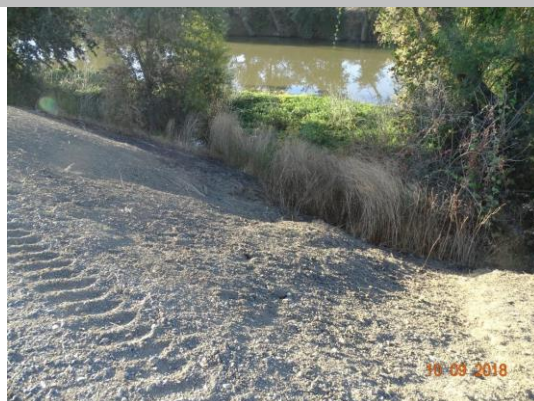
View of erosion on the waterside slope, facing downstream. Fall 2018.

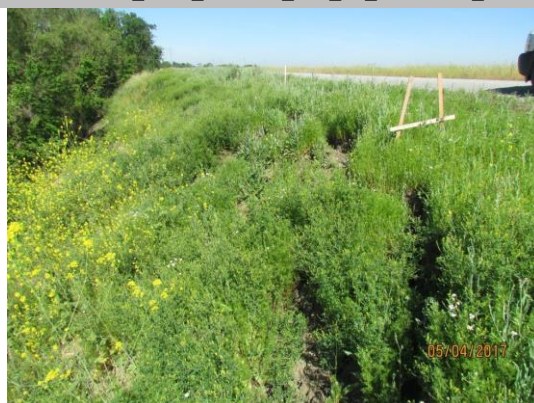
View of sloughing on waterside slope. Spring 2017.

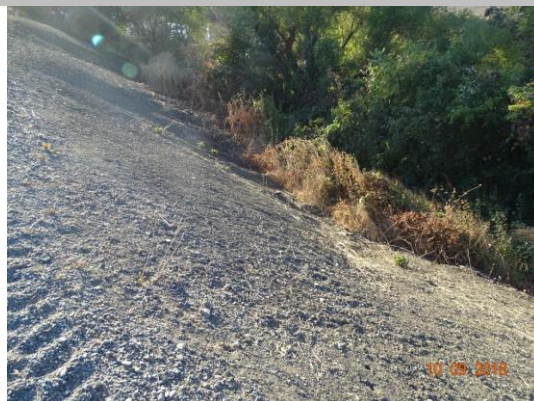
LM Start	0.78	Rating **	A/W	Issue No.	16
LM End	0.78	Issue Type +	Ma	Location *	WS
Category	Earthen Levee			GPS Latitude/Longitude	
				Start	End
Item	Erosion / Bank Caving			38.796042 °	38.796042 °
				-121.737661 °	-121.737661 °
DWR ID	DWR_RD0787_01_s_2017_16				
Comment Code					
E1 : Note and monitor erosion site.					
Inspector Comment					
Erosion on the waterside slope from 2017 storms. Recommend monitoring.

View of erosion on the waterside slope, facing downstream. Fall 2018.
